2017 Ford Super Duty Hitch Update

GNRK1116/GNRK1117 HOLE LOCATION

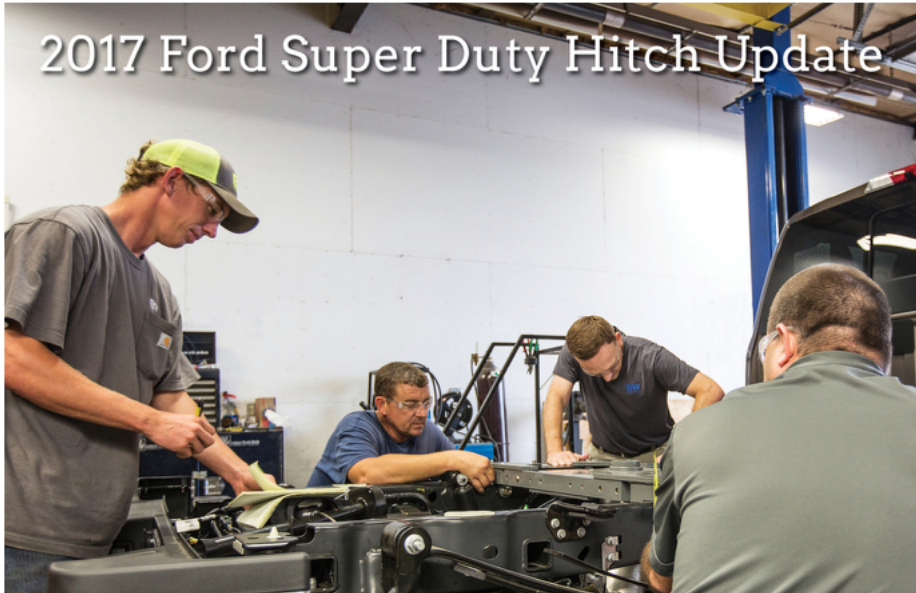
As more 2017 Ford Super Duty trucks get to Ford dealerships, we continue to learn more about how they are arriving from the assembly line. The bed placement on the frame that we have encountered has caused us to change the hole location from 45 3/4" to 45 5/8". This new measurement is reflected in the latest GNRK1116/GNRK1117 instruction sheets, but the earlier instruction sheets will reflect the old measurement. Please let your installation technicians know of this change.

Old Measurement: 45-3/4"

New Measurement: 45-5/8"
